Intel[®] Mobile Celeron[™] Processor at 466 MHz, 433 MHz, 400 MHz, 366 MHz, 333 MHz, 300 MHz, and 266 MHz Specification Update

Release Date: October 2000

Order Number: 244444-019

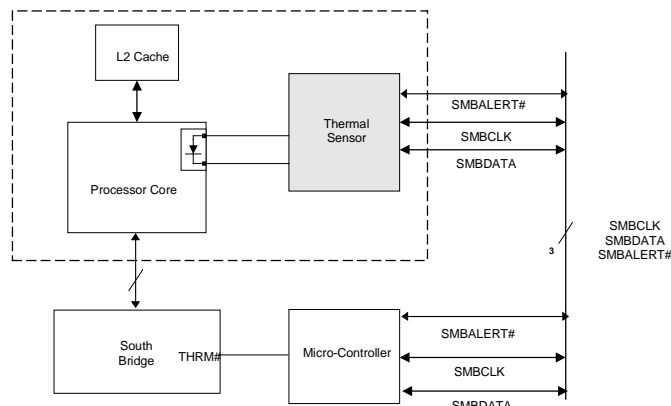
Figure 1. An Example of Microcontroller Driven Thermal Management

Problem: The Intel Celeron Processor Mobile Module has a thermal sensor that monitors the processor core's temperature. Please note that desktop systems could have a similar thermal device. The thermal sensor asserts SMBALERT# if the processor temperature exceeds the temperature limits set in the Alarm Threshold Registers (T_{HIGH} , T_{LOW}). It also sets the corresponding Status Register bits to identify the cause of the interrupt. Figure 1 gives one example of the how the SMBALERT# signal could be used in a system.

Implication: There is no system impact from this erratum if temperature polling is used for processor thermal management. If the SMBALERT# interrupt is employed to manage processor thermal sensing, then servicing the false interrupt may result in premature system action depending on the software and hardware implementations used. The rate of the false interrupts is less than the auto-convert rate of the thermal sensor.

Workaround: Three different (mutually exclusive) workarounds are possible:

1. Before servicing an interrupt from the thermal sensor, read and compare the processor thermal reading with the threshold limits (T_{HIGH} or T_{LOW}). Figures 2 and 3 provide basic flowcharts for the implementation of this workaround in an interrupt driven system.
2. If the firmware implemented polls the Status Register only, then before taking any action, re-read the temperature register and do a comparison with the alarm threshold limits (T_{HIGH} or T_{LOW}) to determine if the value is actually still within the temperature window.
3. Use a temperature polling scheme to monitor the processor temperature.

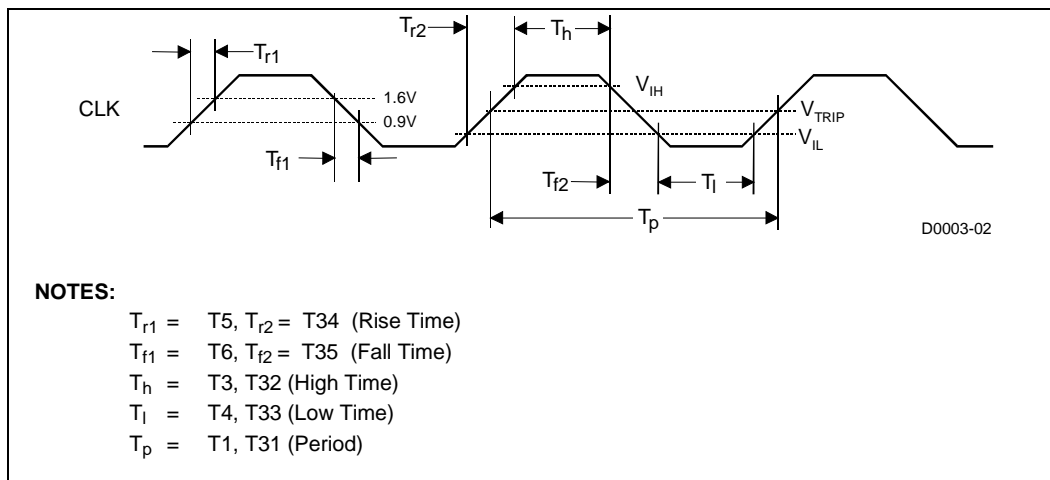
Figure 3.3 Generic Clock Waveform

H11. Generic Clock Waveform Figure

Figure 3.3 in the *Intel® Mobile Celeron™ Processor in μPGA1 and BGA1 Packages at 366 MHz, 333 MHz, 300 MHz, and 266 MHz* datasheet (Order Number 245112-003) has been updated. The following figure is to replace the one in the above document.
